**Barry Ash Pond Review  
Barry Power Generating Facility  
Mobile, Alabama**

**Mobile Baykeeper**

March 23, 2018

**Burgess Environmental**

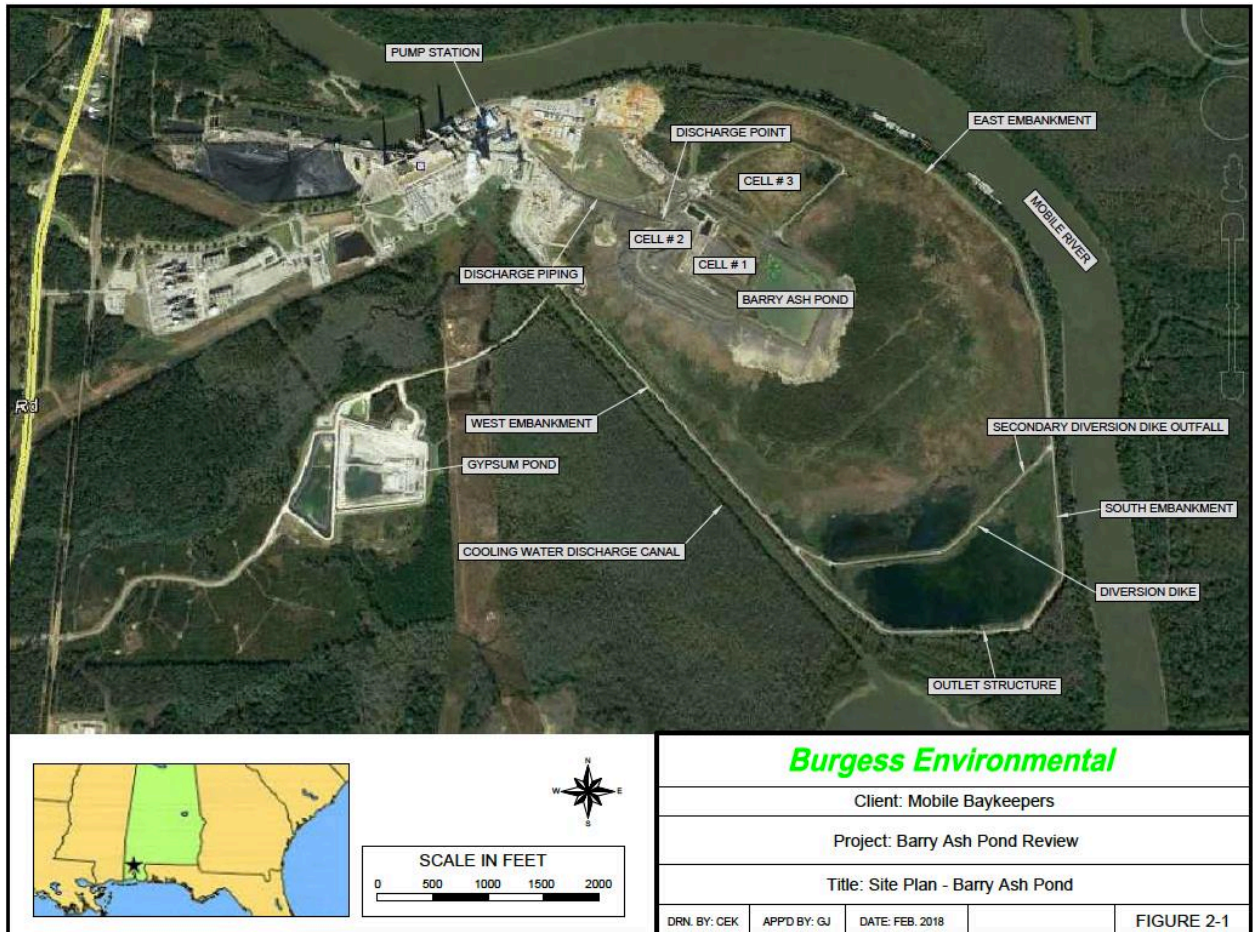
Figure 2-1  
Site Plan - Barry Ash Pond

The Barry Ash Pond is located southeast of the power generating complex (Figure 2-1). The pond is bounded to the north by the Plant, to the east and south by the Mobile River, and to the west and southwest by the Plant cooling water discharge canal. Through essentially all of its history the Barry Ash Pond has not been subject to regulatory oversight.
